Northern California Home Inspection

Property Inspection Report

1234 ANY STREET, ANY TOWN CA, 55555 Inspection prepared for: JOE SMITH & MARY SMITH Agent: Support - Home Inspector Pro

> Inspection Date: 1/20/2010 Time: 1:PM Age: 9 years Size: 2752 sq ft Weather: overcast

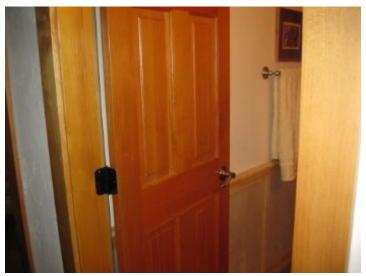
- The bathroom door does not lock.
- Door bell is not functional.

All interior doors are solid hardwood in good condition.

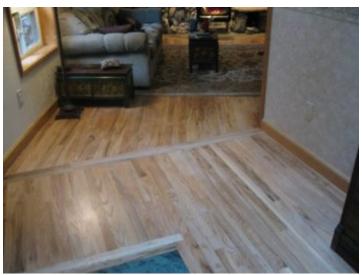
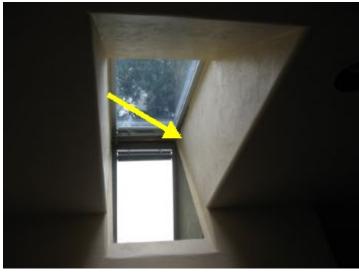
• The home is fitted with vinyl windows.

Skylights in home (4) are all installed correctly as seen and flashed properly. No evidence of any leakage at the time of inspection.

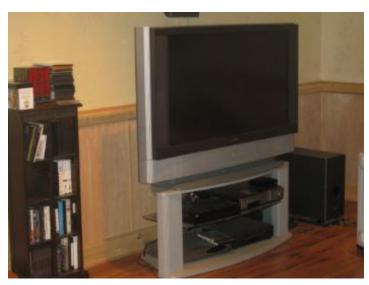
Birch waincoating in entertainment room in good condition as well as floor however it appears the floos at some time got wet as edges of some boards are raised.

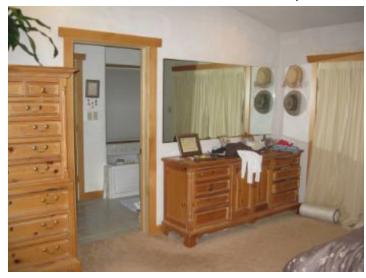
Master bedroom hand tectured walls, woodwork and paint in good condition. Carpet also in good condition.

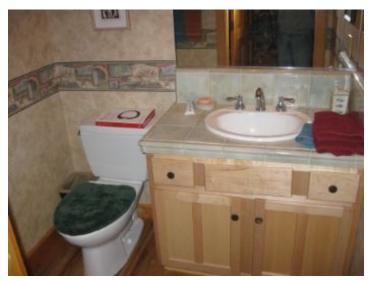
Bath #3 maple cabinet and hardwood floor. China lavy and toilet all functioning properly when inspection was made.

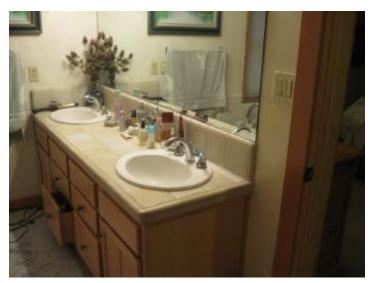
Master bath tile counters and tile floor in good condition. All plumbing in this area of home functioning properly including circulating hjot water system.

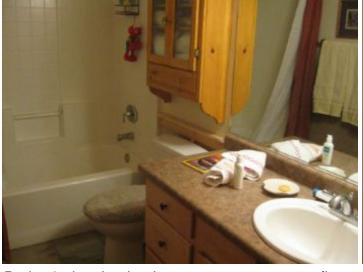
Bath #2 showing laminate countertop, stone floor, maple cabinets and fiberglass 5' tub shower.

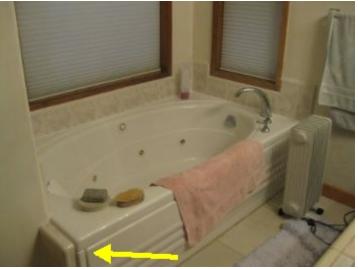
Whirlpool tub in master bath properly wired with GFCI breaker and access to pump and heater systems from front Tile around in great condition as well as woodwork which is water protected and walls.

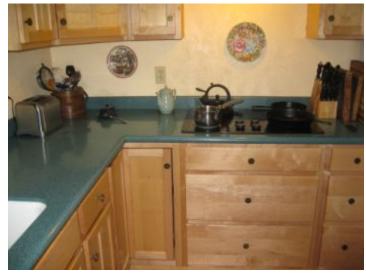
Composite counter tops in kitchen in excellent condition, Glass surface cook top in good condition and fully functioning.

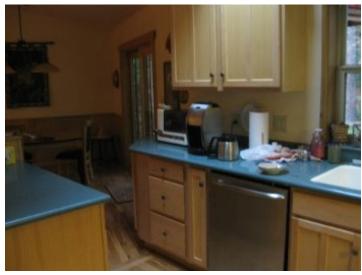
Newer installed disher washer functioned properly during inspection.

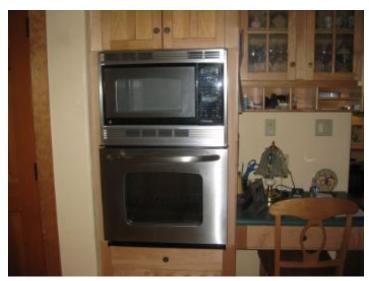
Newly installed stainless steel oven / micro combination. Properly installed with clearances and proper size breaker.

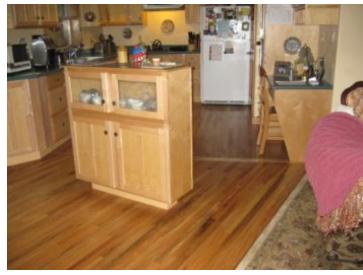
Kitchen hardwood floor recently professionally refinished. Proper clearances between all cabinets for walk ways.

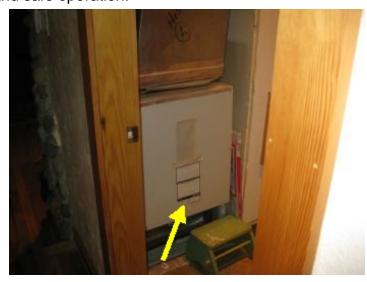
The heating air handler / exchanger is in the laundry and properly functioning and in good condition. Service papers with unit show it has been professionally maintained on a regular basis.

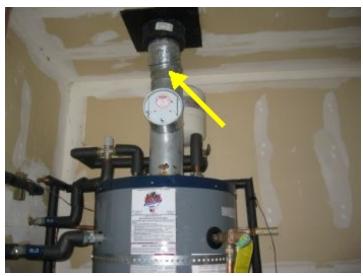
Venting of water system proper with dual wall pipe vent completely to exhaust above the roof. Strapping of system proper.

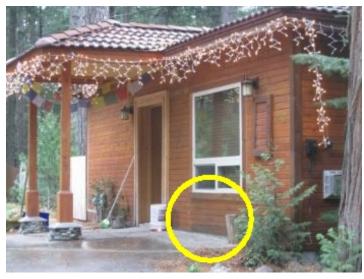
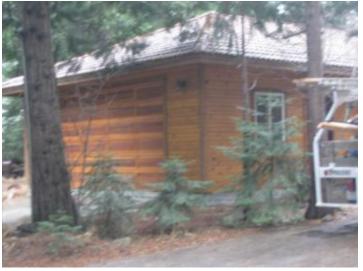
Redwood doors on detached 4 car garage are in good condition and fuction with electric openers properly at time of inspection.

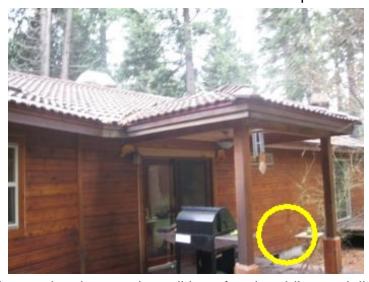
- No major system safety or function concerns noted at time of inspection.
- Some areas need restaining, or priming and repainting.
- Some siding deterioration noted. Have repaired as necessary.
- Dryer vent cover is damaged.
- Trees within 6 feet foundation. Monitor for potential root damage.

Covered rear entry to home showing good condition of cedar siding and tile roofing. Siding needs minor work on the staining in some areas where water from irrigation has been hitting the home.

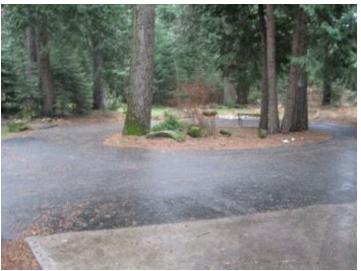
Asphalt driveway in good condition. Concrete apron poured in front of all garage openings with proper slope for water.

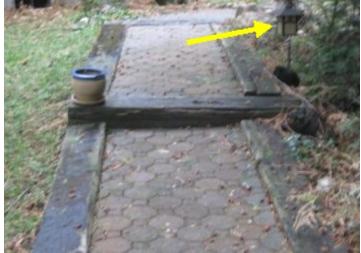
Interlocking brick walkways and exposed aggragate sidewalks are the surface area of all exterior walk ways. They are in good condition with lighting at all steps.
