Northern California Home Inspection

Property Inspection Report

1234 ANY STREET, ANY TOWN CA, 55555 Inspection prepared for: JOE SMITH & MARY SMITH Agent: Support - Home Inspector Pro

> Inspection Date: 1/20/2010 Time: 1:PM Age: 9 years Size: 2752 sq ft Weather: overcast

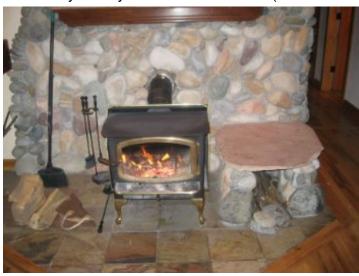
• Level II inspection—The National Fire Protection Association (www.nfpa.org) advises that each chimney receive a Level II inspection each time a residence is sold. Inspection levels are explained at www.csia.org/pressroom/press-inspection-levels-explained.htm. It is also advised that this inspection be conducted by a chimney sweep certified by the Chimney Safety Institute of America (www.csia.org).

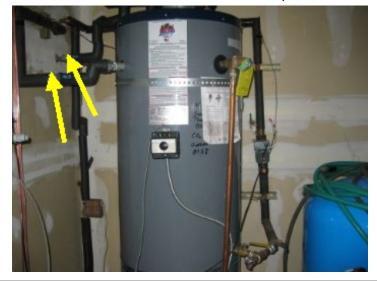
• No deficiencies observed at the visible portions of the supply piping.
